Preferred Home Inspections, Inc.

PROTOCOL FOR REMEDIATION

Date: April 27, 2018

Date of Original Inspection: March 3, 2018

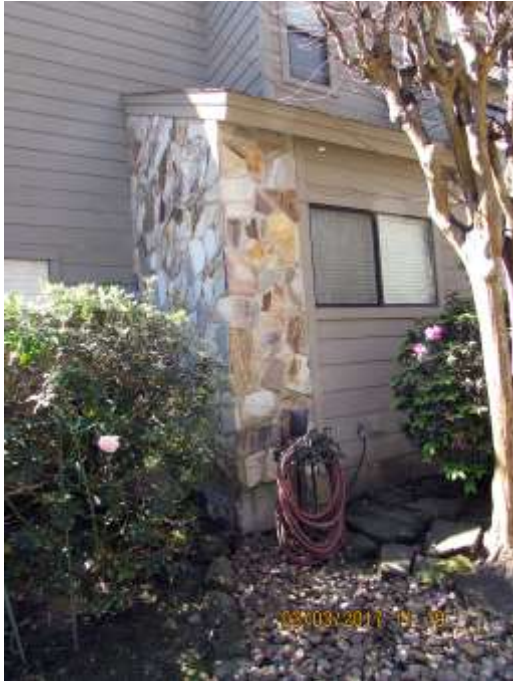
Laundry room exterior

The inspection determined that above some of the wet wall areas, roof flashing as incorrect or in need of replacement as well as siding. These must be corrected/repared prior to any remedial work.

It is also very possible that the actual stone cladding on some of the outside areas, such as the laundry room, powder and master bath toilet rooms is causing water penetration to the interior walls and may have to be removed when other causes are eliminated. The best method is to remove the wallboard of the above areas (laundry room and two bathrooms) under mold containment protocols, then call us to return for an examination of the water staining evidence. Stone removal would be the last resort.

A containment entry outside the laundry room door that has separate entry to the exterior breakfast room wall and laundry room needed in order to isolate for proper clearance testing after removal of all cabinetry and wallboard.

The containment of the laundry room should include sealing off the pantry that is within the room. The cabinetry within the room, including shelving, countertop and sink must be removed from the rear wall and window wall to include the fur down. The wall adjacent to the pantry door must be removed up to the door casing. Baseboard removal needed – do not save. All insulation on the exterior walls to be bagged and removed from the area through an open window. Removal of all vinyl wall paper needed.

Two negative air machines to be used, one in each of the containments. Two containment areas needed in order to properly test for clearance. The polyethylene must billow slightly inward in order to have negative pressure. Any air returns or registers within the containment areas must be sealed off. The units should run a minimum of 24 hours until clearance testing is performed.
