PROPERTY INSPECTION REPORT

Date of Inspection: June 20, 2018

By: Fernando Martinez, Professional Inspector #2945, Wendy Matson #3666, Elissa Martinez #10490

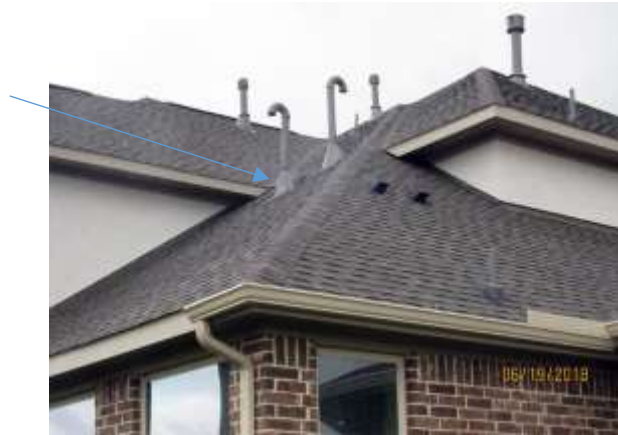
1. 30 year dimensional type shingles.
2. The boot for the water heater, shown below, is allowing moisture into the attic – repair needed. This is also discussed under Attic and Water Heater.

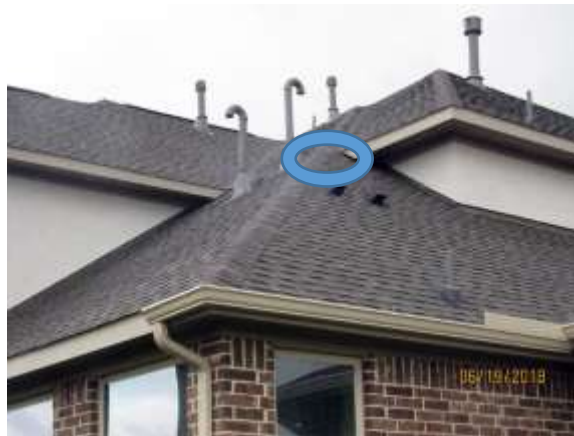
3. A second leak over the master bedroom was seen in the attic. Due to ductwork and lack of accessibility, inspector is not sure of the cause, however, the area is pinpointed in the photo below.

Circled above is the general area of this leak; it could be a shingle problem

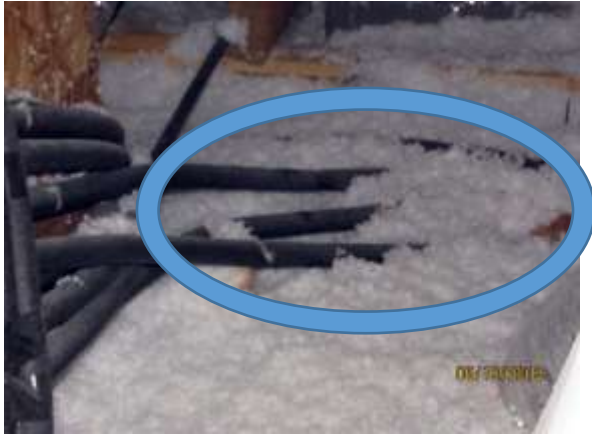
Since the house has had a roof since March of this year, it is likely that leaking has been occurring all this time. The area underneath the lines shown below very likely has mold growth on the sheetrock ceiling of the master bedroom. Part of the repair of this problem must include removing insulation (in order to replace and seal the gypsum

The area circled, left photo, shows where insulation must be removed and documented by contractor or his men with photos as to the condition of the gypsum ceiling below, the cause of the problem and the repair performed.

with an encapsulant paint after being removed by someone wearing an N95 mask).
Recommend also installing walkway to be able to access this area

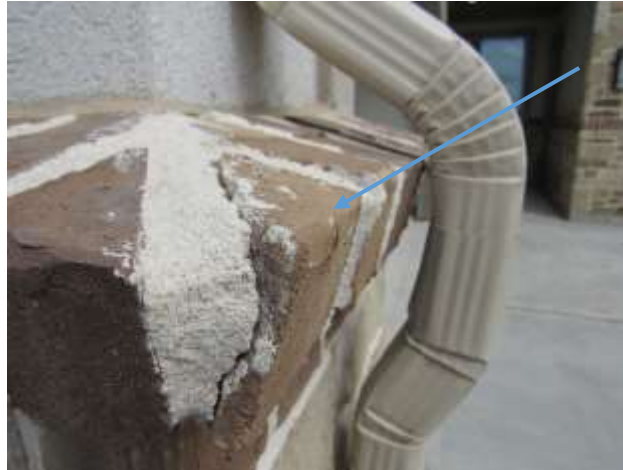
1. The cladding of this home is natural stone and hard coat stucco with cement board cornicework.(note)
2. Brick is cracking off the ledge at the front corner. This brick should be removed and reset.

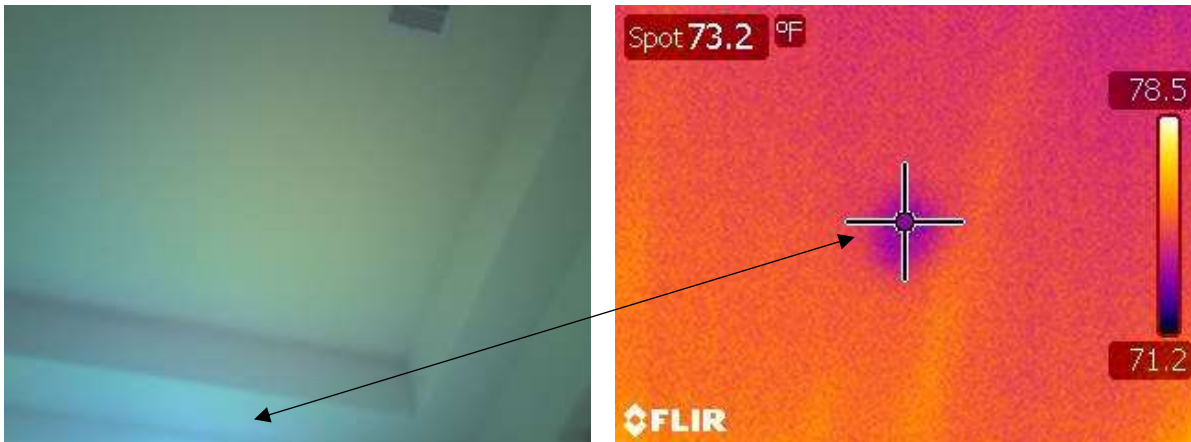
- 1. Two leaks were found in the first floor of this home using the infra-red camera:
 - a. Inside master bedroom at ceiling of the wall that is adjacent to the bathroom
 - i. Confirming that the spot was moisture using the Delmhorst BD2100, a .7%, scale 3, was found. This is due to a leak in the attic above (also discussed under “Attic”).

The digital image of the area discussed, above left, and duplicate infra-red image, above right, shows a “moisture signature” as blue (cooler) against a background of yellow/orange, which is warm/dry

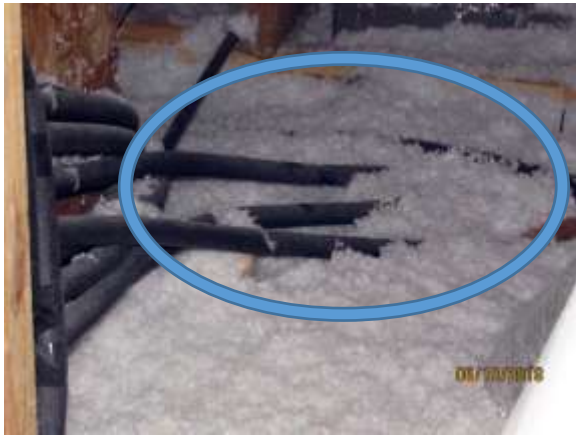
Area in attic affected by leak

Also discussed under roof, this repair requires that repairperson take photos of gypsum ceiling below after insulation is removed and also photos of the cause and the repair.

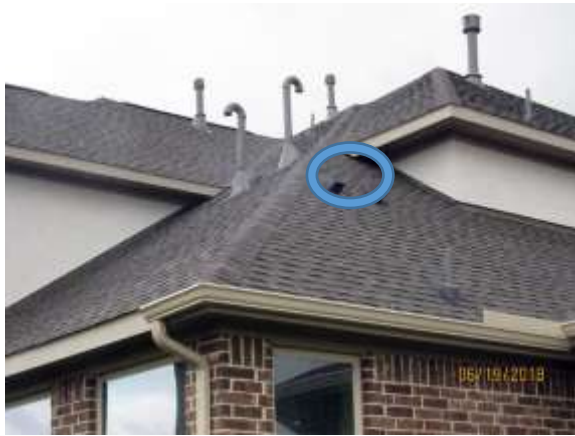
General area of incoming moisture

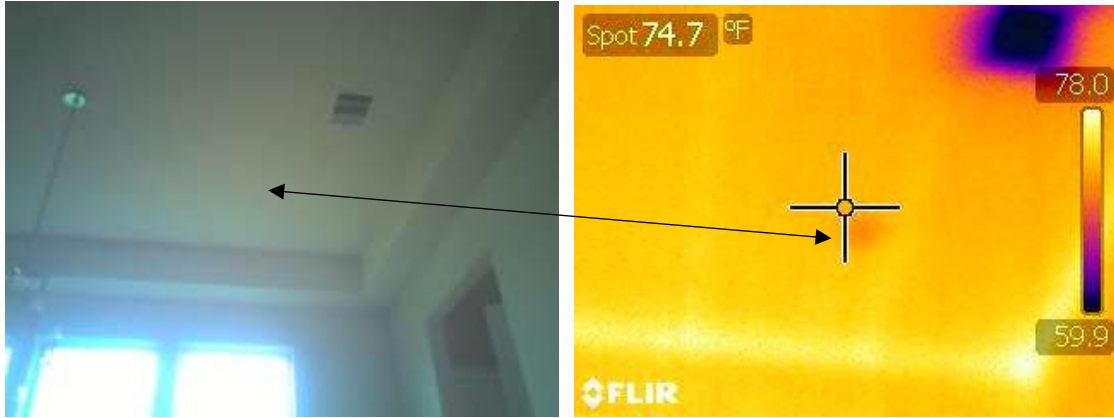
- b. In the formal dining room between the window and the air register
 - i. Confirming that the spot was moisture using the Delmhorst Bd2100, a .7%, scale 3, was found, indicating present moisture. The cause of this leak was not determined.

The digital image of the area discussed, above left, and duplicate infra-red image, above right, shows a “moisture signature” as blue (cooler) against a background of yellow/orange, which is warm/dry

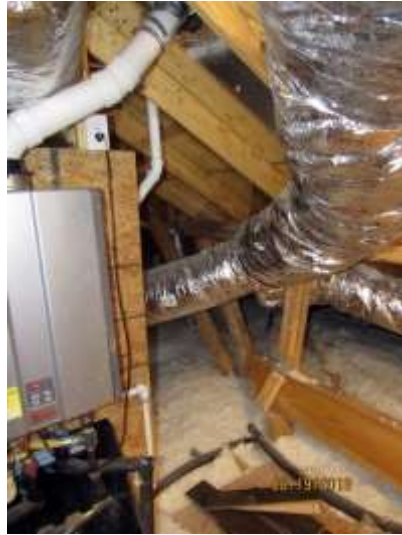
- c. A third leak was found in the attic over the master bedroom and was due to a leaking boot for the water heater flue, also discussed under Attic and Water Heater. This leak did not appear on any ceiling in the home since the moisture landed on osb decking next to the water heater. (note)

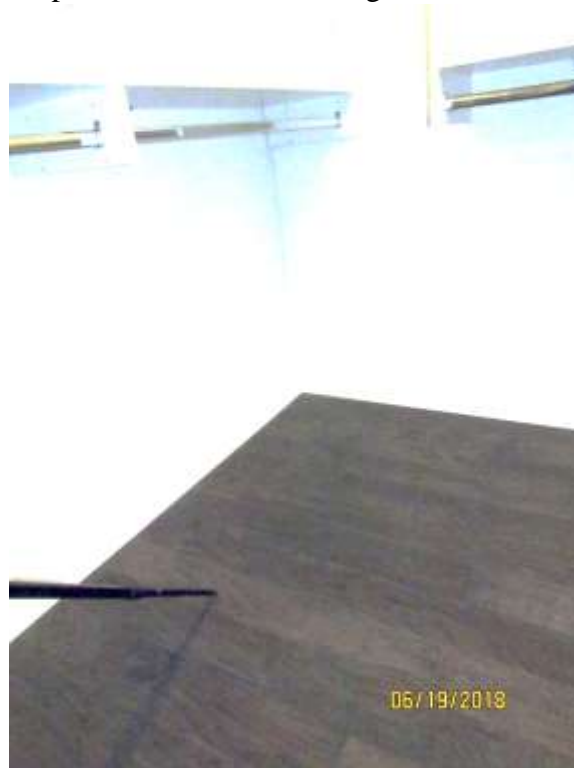
2. The flooring, both tile and wood, were checked for adherence to the subfloor by “tapping” with a tapper to “hear” any hollowness in the tile or wood flooring, which would indicate that the tile or wood is not adhered fully or at all.
 - a. One strip in master closet, rear right wall

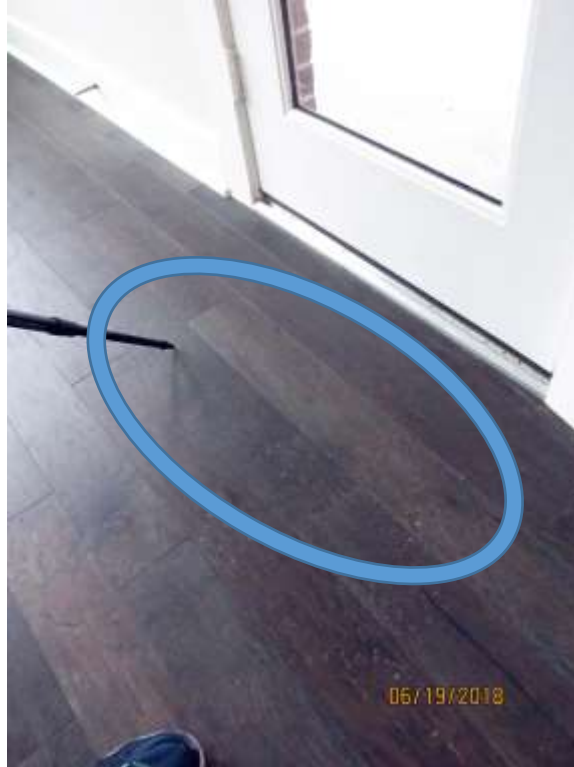
b. Several strips at breakfast room exit door to exterior

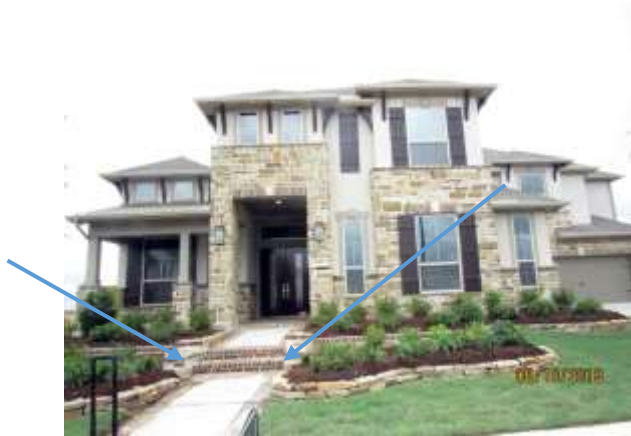
1. The front two sidewalls were built extremely crooked, shown below. Recommend to rebuild.

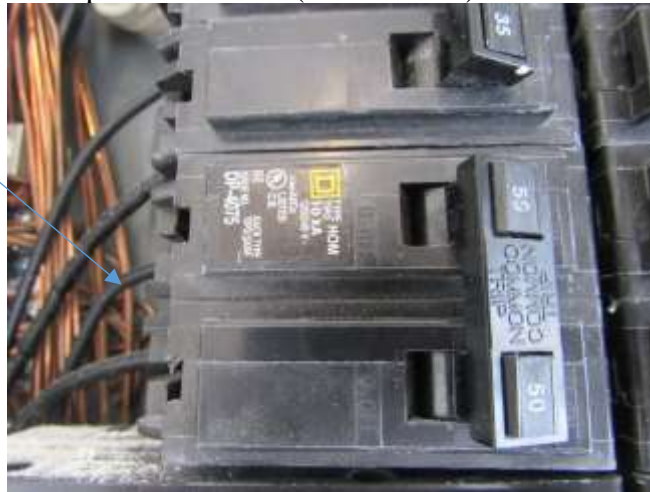
1. The following information, unless otherwise written “deficiency” is considered a note for reference purposes:
 - a. Type: Underground (note)
 - b. Brand of panel box: Square D (note)
 - c. Location: inside garage (note)
 - d. The size of service is: amp service on (size) and type aluminum line (no anti-oxidant on line ends)
 - e. Room for additional circuits? yes (note)
 - f. Incoming volts: 245 (both legs were equal to within + or – 1 to 3 volts), which is adequate (note)
 - g. Type of system: 3-wire grounded system (note)
 - h. Condensing unit breakers do match the manufacturer’s requirements, however, the wiring that runs between the condenser and the panel box are INCORRECTLY sized. Deficiency

50 amp breaker = #10 (must be a #6)

This line is too small

36 amp breaker = #10 (must be #8) or reduce breaker size

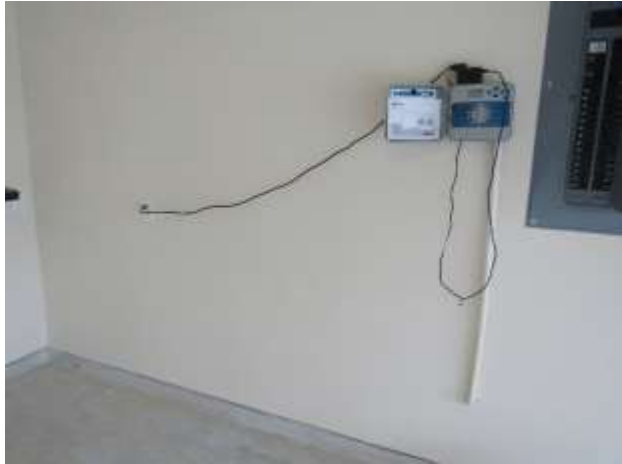
1. The sprinkler system was plugged into an extension cord because the outlet was too far away. Another outlet must be installed.

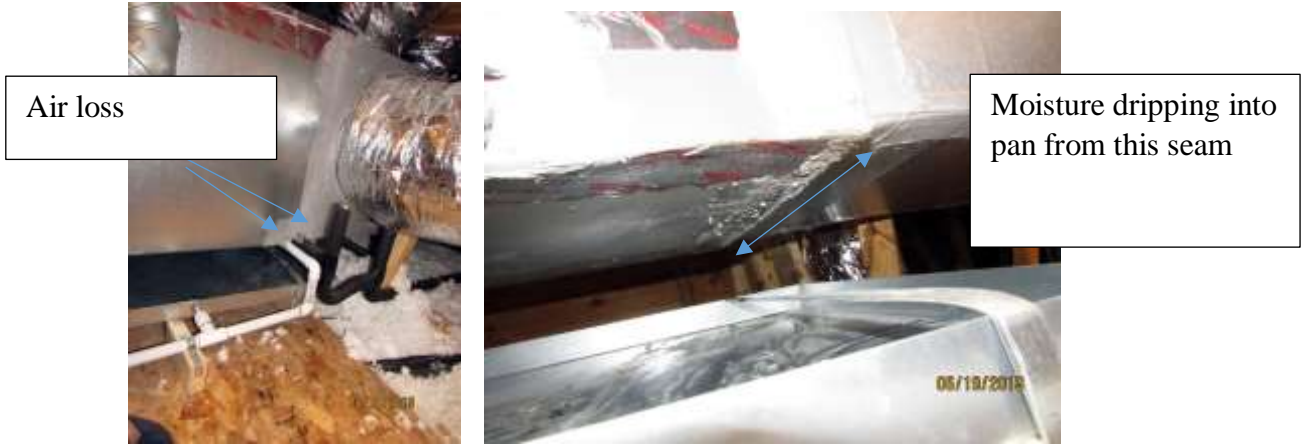
- a. Unit at right side of attic upon entering
 - i. Condensation drips into the pan due to lack of enough neoprene insulation and/or proper sealing around the protrusions, shown below. Additionally, dripping between the evaporator coil and the plenum is occurring and beginning to rust the unit. This MUST be repaired.

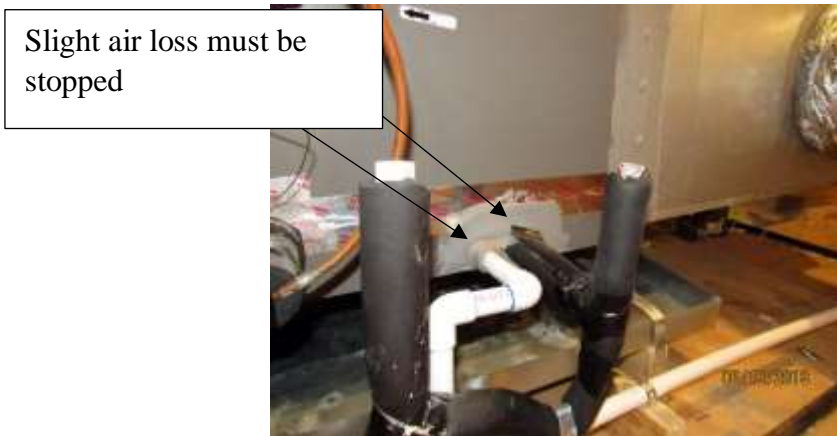
- a. Unit on left side upon entering attic
 - i. Condensation drips into the pan due to lack of enough neoprene insulation and/or proper sealing around the protrusions, shown below. Need to use UL silver tape covered with high velocity duct sealant.

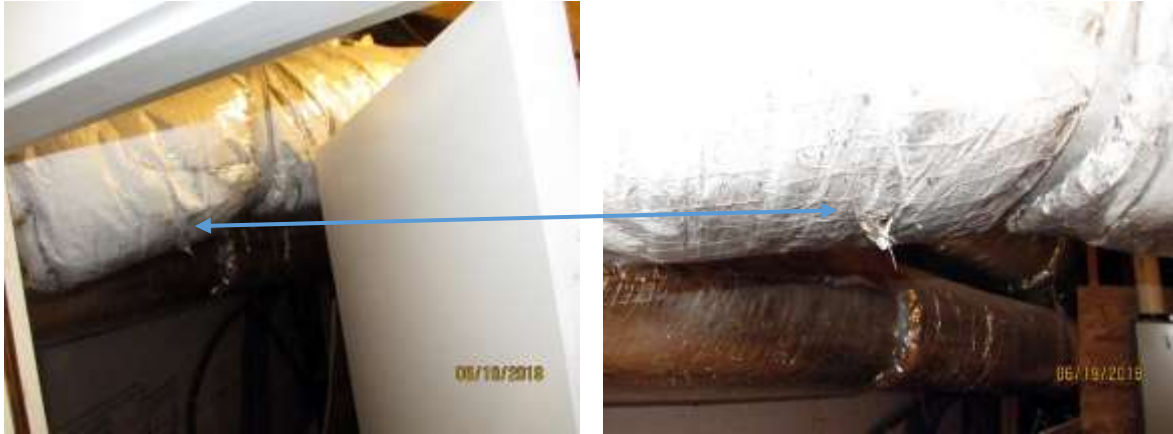
- 1. Duct in the walk-in attic, which must be raised, is also damaged. UL silver tape repair

needed.

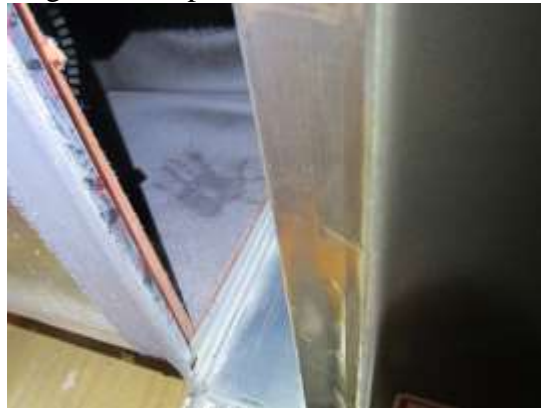
2. The air return, prior to the media filters, is filled with sheetrock dust. Both units are in need of vacuuming of return plenum.

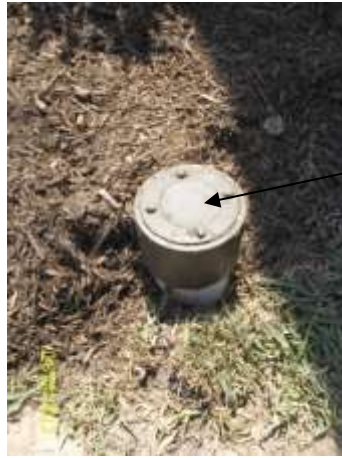
1. The whole house drain line was located at the front elevation. It must remain exposed (don't cover with mulch). The anti-back up valve cover is painted shut. Repair or replace.

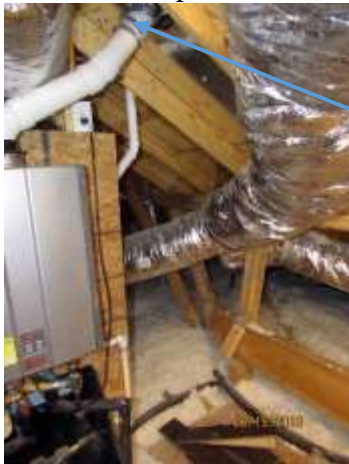
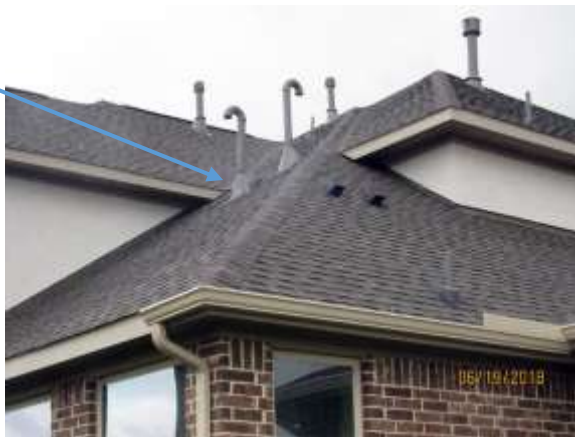
1. As discussed under attics, rain was penetrating into the attic where this unit is located from the flue protrusion; also discussed under "Roof". Repair needed.
