PROPERTY INSPECTION REPORT

Date of Inspection: June 20, 2018

By: Fernando Martinez, Professional Inspector #2945, Wendy Matson #3666, Elissa Martinez #10490

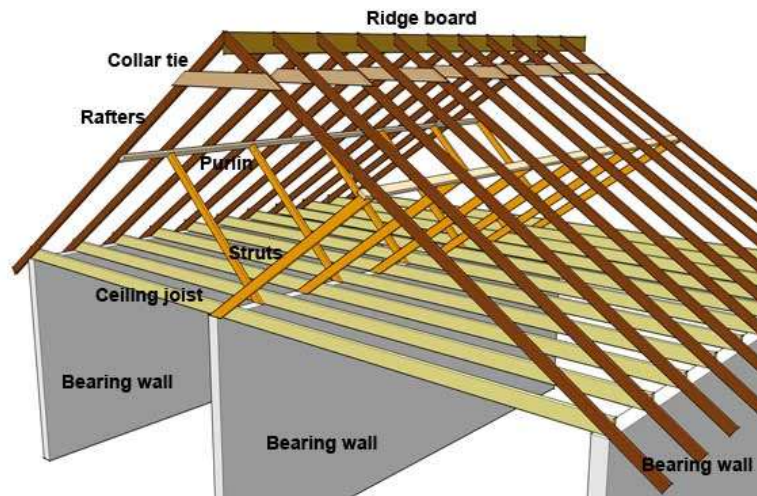
- ii. Attic framing (in attic): 2" x 8" ridge with 2" x 6" rafters, spaced 24" on center (notes) with all properly installed support framing.

Diagram above illustrates attic framing terminology

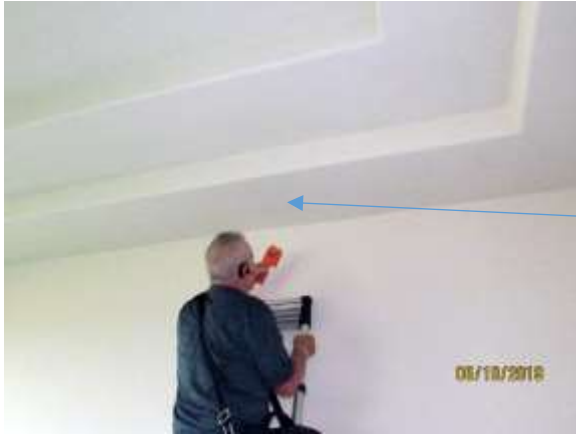
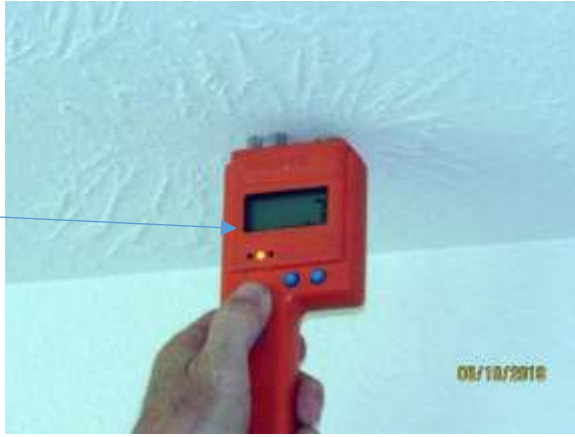
- 1. Two leaks were found in the first floor of this home using the infra-red camera:
 - a. Inside master bedroom at ceiling of the wall that is adjacent to the bathroom
 - i. Confirming that the spot was moisture using the Delmhorst BD2100, a .7%, scale 3, was found. This is due to a leak in the attic above (also discussed under “Attic”).

The digital image of the area discussed, above left, and duplicate infra-red image, above right, shows a “moisture signature” as blue (cooler) against a background of yellow/orange, which is warm/dry

Reference scale for **gypsum (#3)** is as follows
0% to 0.4% normal moisture
.5% shows beginning of moisture
.6 to .9% medium moisture - moisture may be leak or chronic water penetration
1% and over – indicates complete saturation - due to a leak or chronic water penetration

Also discussed under roof, this repair requires that repairperson take photos of gypsum ceiling below after insulation is removed and also photos of the cause and the repair.

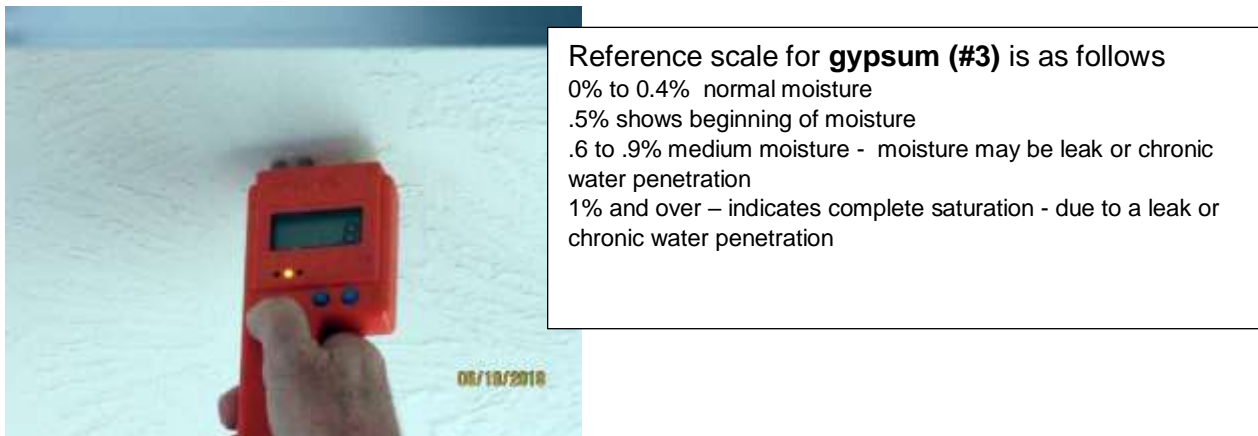
- b. In the formal dining room between the window and the air register
 - i. Confirming that the spot was moisture using the Delmhorst Bd2100, a .7%, scale 3, was found, indicating present moisture. The cause of this leak was not determined.

The digital image of the area discussed, above left, and duplicate infra-red image, above right, shows a “moisture signature” as blue (cooler) against a background of yellow/orange, which is warm/dry

Also discussed under roof, this repair requires that repairperson take photos of gypsum ceiling below after insulation is removed and also photos of the cause and the repair.

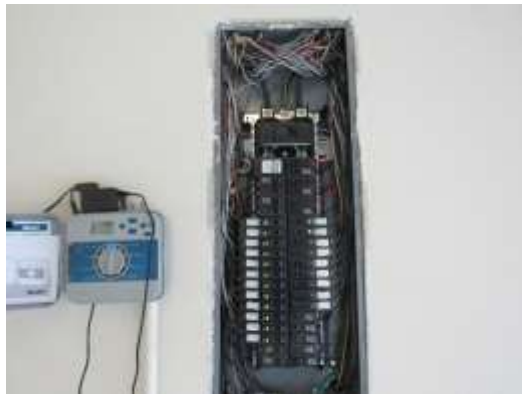
1. The following information, unless otherwise written “deficiency” is considered a note for reference purposes:
 - a. Type: Underground (note)
 - b. Brand of panel box: Square D (note)
 - c. Location: inside garage (note)
 - d. The size of service is: amp service on (size) and type aluminum line (no anti-oxidant on line ends)
 - e. Room for additional circuits? yes (note)
 - f. Incoming volts: 245 (both legs were equal to within + or – 1 to 3 volts), which is adequate (note)
 - g. Type of system: 3-wire grounded system (note)
 - h. Condensing unit breakers do match the manufacturer’s requirements, however, the wiring that runs between the condenser and the panel box are INCORRECTLY sized. Deficiency
